# Manhole Inspection Summary

Manhole # S43II\_017MH

Insp Date: **4/24/08 12:33 PM**

**Location** Address: **Rutland Ave**

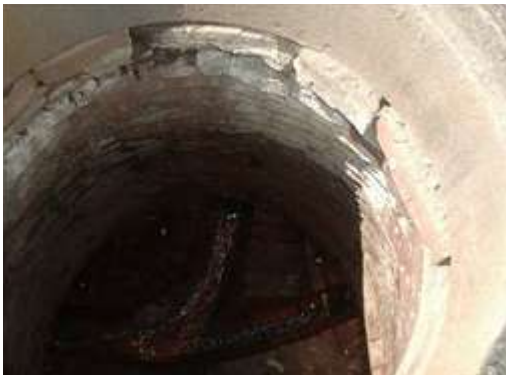
Defect 1

Condition: ☐ Sound ☐ Cracked ☐ Root Intrusion ☒ **Loose Brick** ☒ **Deteriorated**

Deterioration

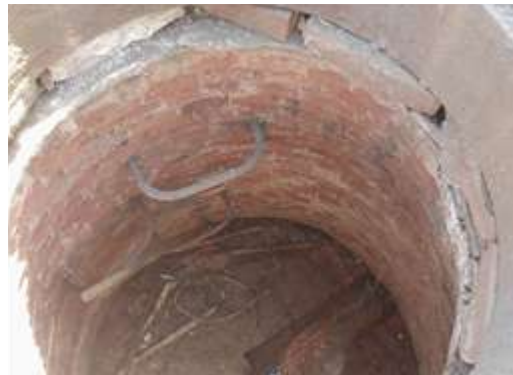
Defect 2

Loose Bricks

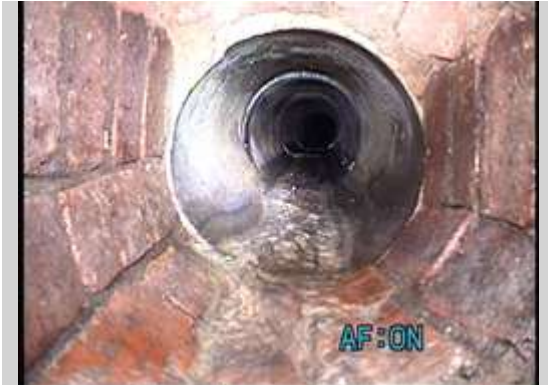
12 O'Clock Outflow

8 in. Circular Gravity Sewer  
Pipe Out @ 12 O'Clock

Pipe Height: **8.4** (in.) Rod and Bar (Angled)  
Pipe Material: **Clay** ☐ Pipe Lined  
Invert Depth: **7.60** (ft.) Flow Characteristics: **Fast**  
Deposits: ☒ None ☐ Mud ☐ Sludge ☐ **Debris** ☐ Grease  
Silt Depth: (in.) Deposits Extent:  
Infiltration: **None** Pipe Seal Cond: **Sound**

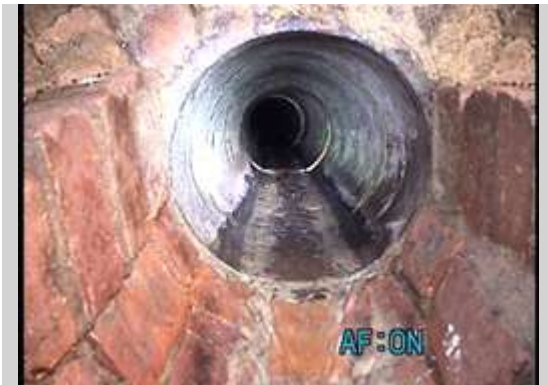
3 O'Clock Inflow

8 in. Circular Gravity Sewer  
Pipe In @ 3 O'Clock

Pipe Height: **8.4** (in.) Rod and Bar (Angled)  
Pipe Material: **Clay** ☐ Pipe Lined  
Invert Depth: **7.10** (ft.) Flow Characteristics: **Fast**  
Deposits: ☒ None ☐ Mud ☐ Sludge ☐ **Debris** ☐ Grease  
Silt Depth: (in.) Deposits Extent:  
Infiltration: **None** Pipe Seal Cond: **Sound**

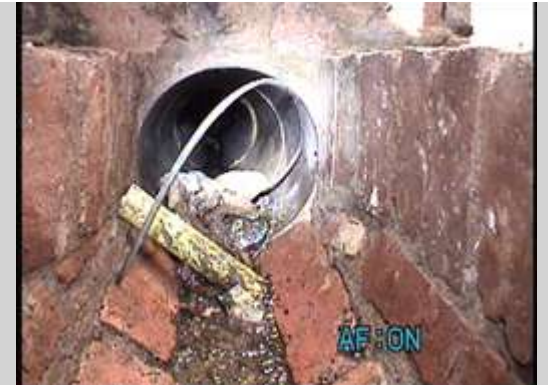
5 O'Clock Inflow

Deposits: ☐ None ☐ Mud ☐ Sludge ☒ **Debris** ☐ Grease

Silt Depth: **2** (in.) Deposits Extent: **Light**
